DELAWARE RIVER BASIN
ALLOWAY CREEK, SALEM COUNTY
NEW JERSEY

ALLOWAY LAKE DAM

NJ 00038

PHASE 1 INSPECTION REPORT
NATIONAL DAM SAFETY PROGRAM

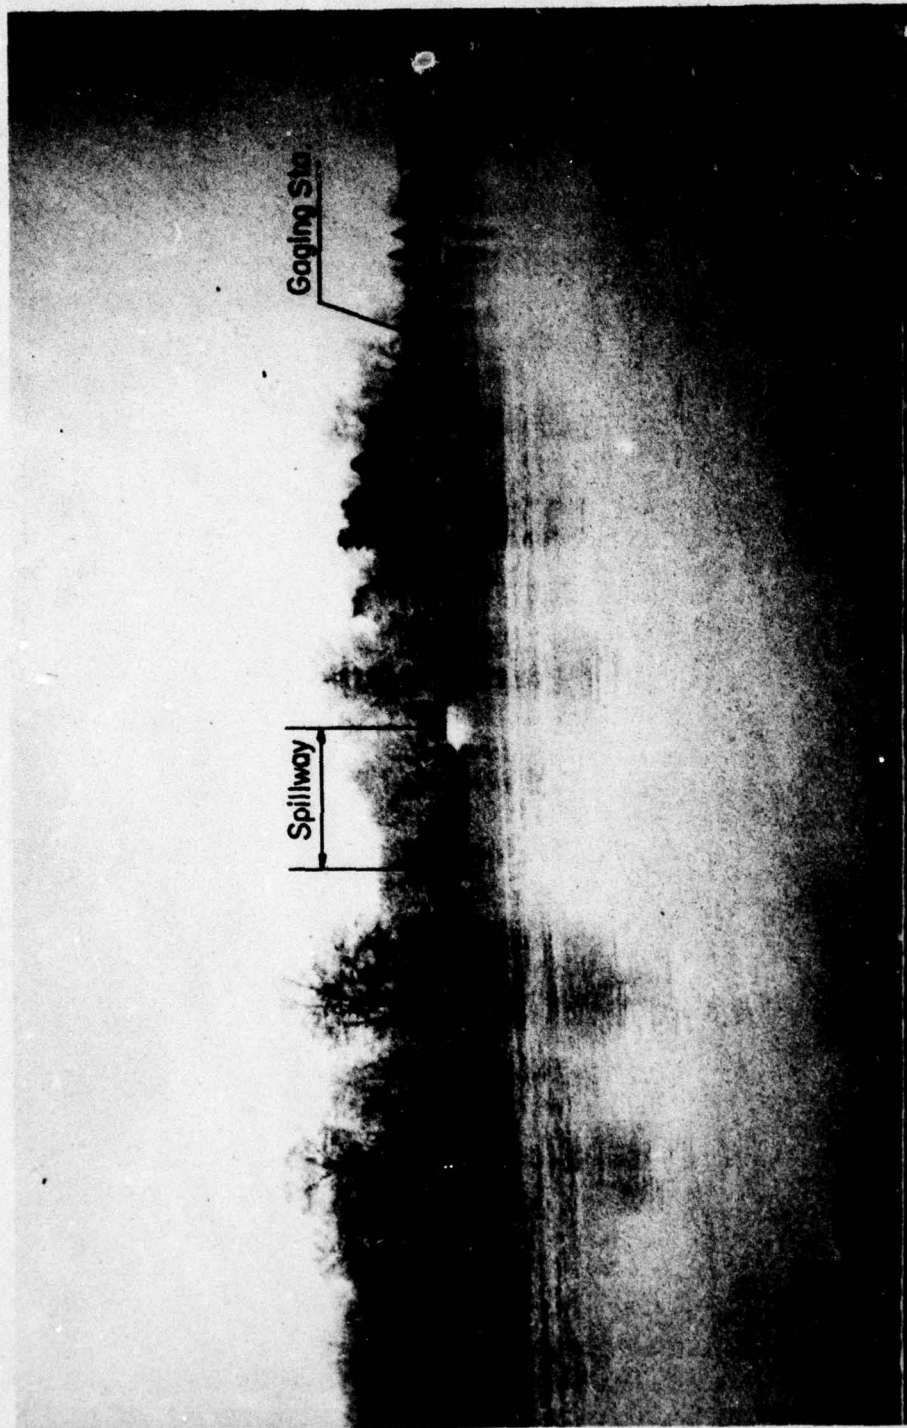
OVERVIEW OF ALLOWAY LAKE DAM

Alloway Lake Dam is assessed to be in a generally fair overall condition but refilling of the downstream stilling basin below the spillway should be undertaken very soon to preclude a collapse of the lower portion of the spillway apron. Sufficient engineering data was not available to ascertain the continued long-term stability of the embankment as three previous breachings have completely washed out wide zones of embankment and further engineering studies are recommended to be undertaken in the near future. Recommended remedial actions also to be undertaken very soon include protecting the auxiliary spillway outlet channel, regrading the dam crest and repairing the natural drainage swales on the embankment backslopes.
